**FLOOD INVESTIGATION REPORT**  
Under Section 19 of the Flood and Water Management Act 2010

**South East Leeds**  
8<sup>th</sup> & 10<sup>th</sup> August 2014

**Prepared by**  
**Flood Risk Management Team**  
**City Development Directorate**  
**Leeds City Council**  
**July 2015**

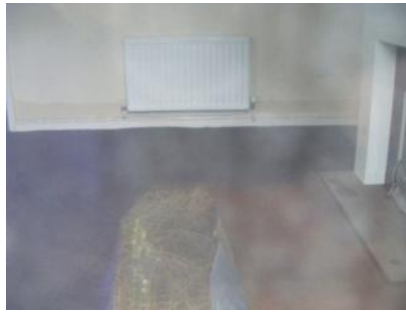
Figure 5: Flood damage to homes in Allerton Bywater. Note tide mark along back wall

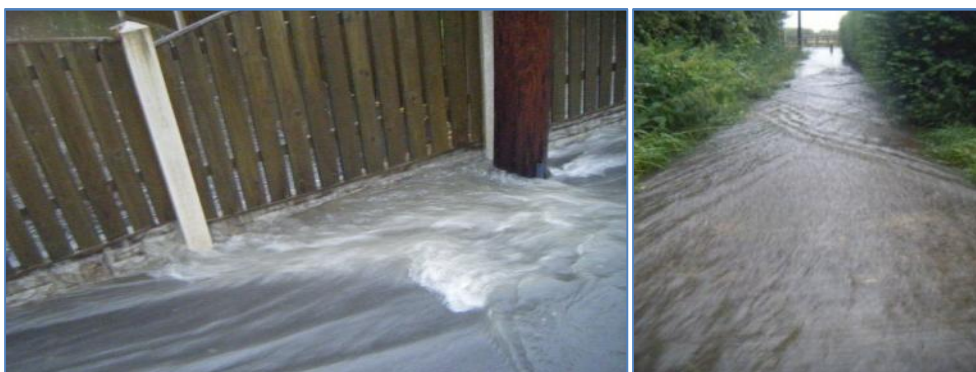
From resident eye witness accounts and observations on the night by FRM staff, the watercourse did come out of its channel due to the throttling effect of the downstream 229mm culvert. This allowed immense volumes of floodwater to escape and gravitate overland to low lying areas in this densely populated area of Allerton Bywater. The resultant overland flow flooded all in its pathway and was compounded by additional flow contributions from other surcharged drainage systems, paved areas, developed areas and run-off from any open spaces caused by saturated land as shown in figure 9. Visual inspection by Leeds City Council surveyors has revealed no blockages or defects.

Figure 9: overland flood water from open watercourse surcharge heading towards Leeds Road

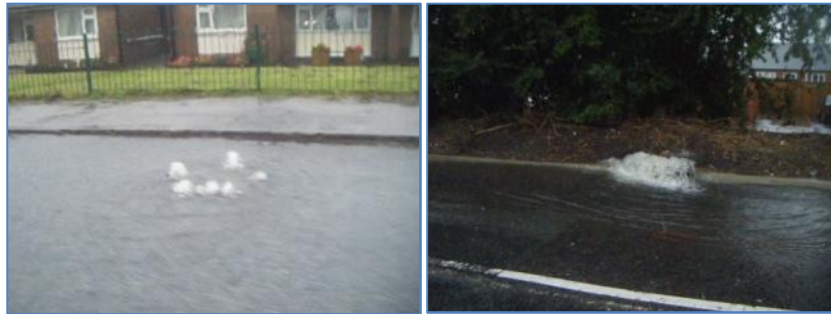
Due to overwhelming water surcharge pressure, numerous manhole covers were blown off, allowing immense volumes of flood water to escape and gravitate to, and flood low lying areas. Any drainage system connected to the sewer network would consequently experience similar surcharge/overload conditions depending on relative levels. See figure 10 below.

Figure 10: surcharging YW manholes, Allerton Bywater

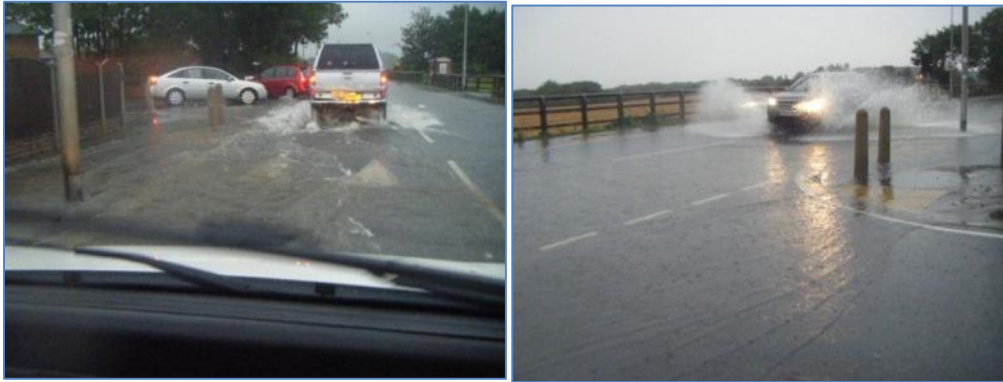
Road gullies in general were not functional, regardless of their service condition, at peak flows due to the surcharge conditions of receiving drainage systems, but the extreme nature of this rainfall event would have far exceeded the design criteria for the highway drainage. The resultant overland flows were a contributory factor to flooding as can be seen in figure 11.

Figure 11: Leeds Road flooding at junction with Doctors Lane, Allerton Bywater

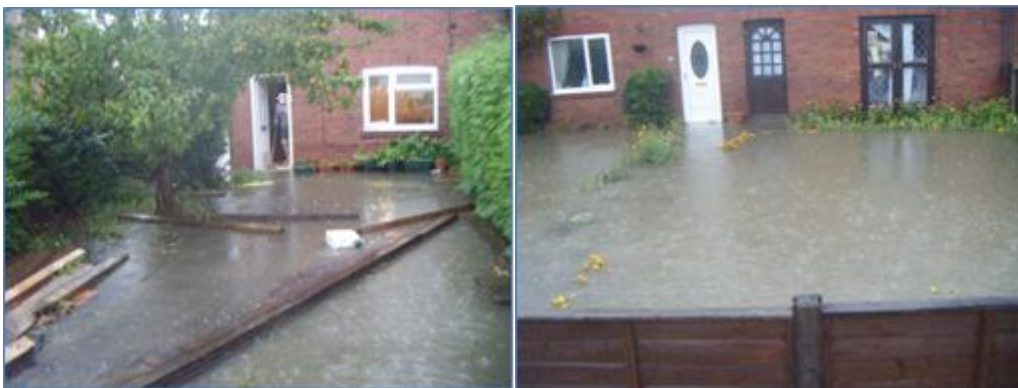
3.2.15 The primary cause of the flooding was by surface water (pluvial flooding) flooding. Causing many drainage systems to be surcharged, watercourses, culverts, public sewers/manholes, private drains and road gullies from the extreme volume of water. See figure 12.

Figure 12: flooding along Leeds Road, Allerton Bywater

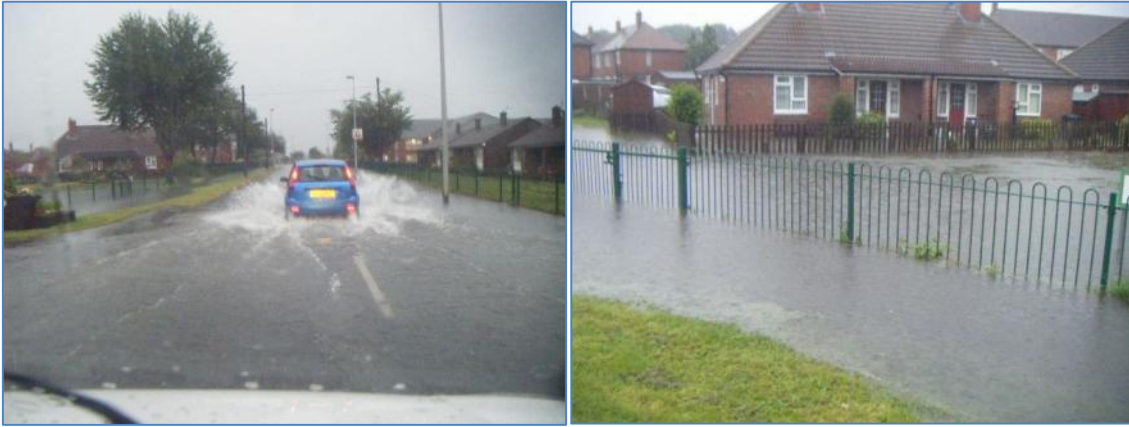
- 3.2.16 This overload of the drainage systems mentioned above was itself caused by extreme surface water runoff from the rural areas occupying higher ground to the North West of Allerton Bywater to the north of the redundant railway embankment.
- 3.2.17 The railway embankment acts as a buffer but flows are then concentrated and channeled towards the residential areas by 1) a 900mm dia culvert under the railway embankment and 2) Doctors Lane (see figure 11 above).
- 3.2.18 The primary cause of localised flooding along Highfield Drive was the extreme volume of water, which appears to have been exacerbated by the capacity of the public combined and surface water sewers. See figure 13.

Figure 13: Highfield Drive flooding

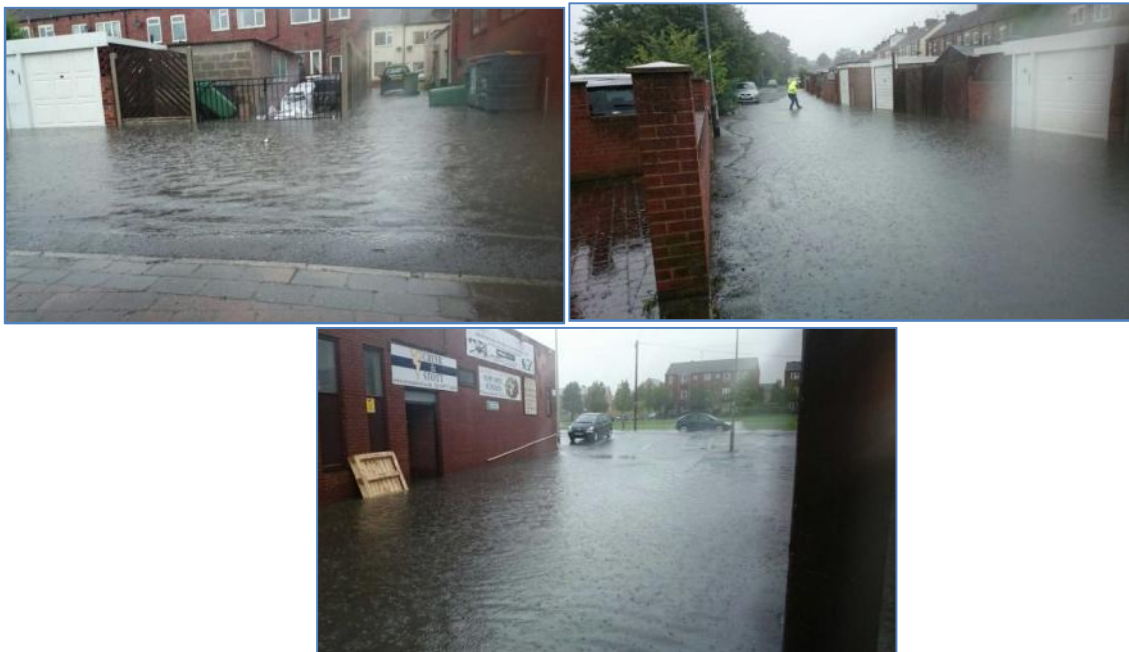
3.2.19 The primary cause of localised flooding along Robinson Street (see figure 14) was the extreme volume of water, which appears to have been exacerbated by the capacity of the public combined / surface water sewers and road gullies. Upon inspection, there were no issues with the open watercourse beck outfall adjacent to Robinson Street.

Figure 14: Robinson Street flooding

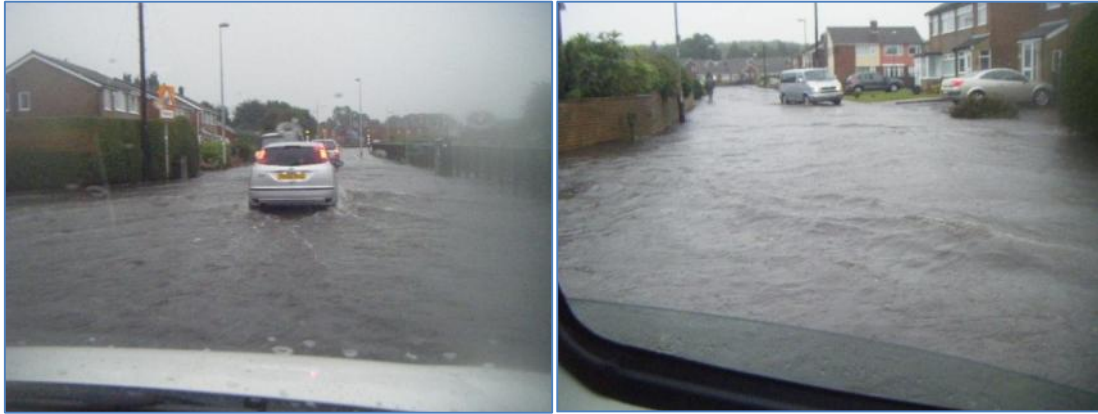
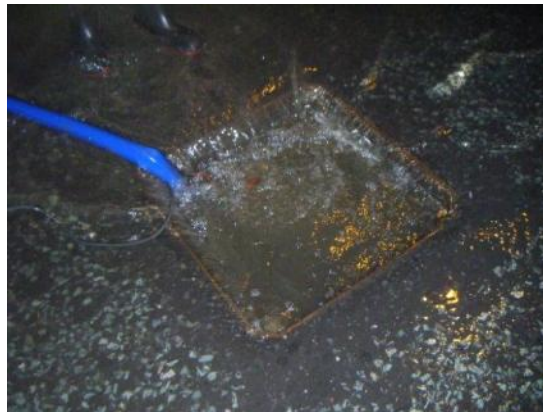
3.2.20 The primary cause of localised flooding at the junction of Leeds Road and Manor Park Avenue (LCC Pumping Station) was the extreme volume of water, which appears to have been exacerbated by potential problems associated with the failure of the pumping station. The pumping station tripped out following a local electrical supply failure. It was reset the following day and the internal control panel has been subsequently reconfigured. See figures 15 and 16.

Figure 15: Leeds Road and Manor Park Avenue (LCC Pumping Station)

Figure 16: FRM Contractors pump Leeds Road flood into adjacent flood plain to reopen road, Friday evening, August 8<sup>th</sup>

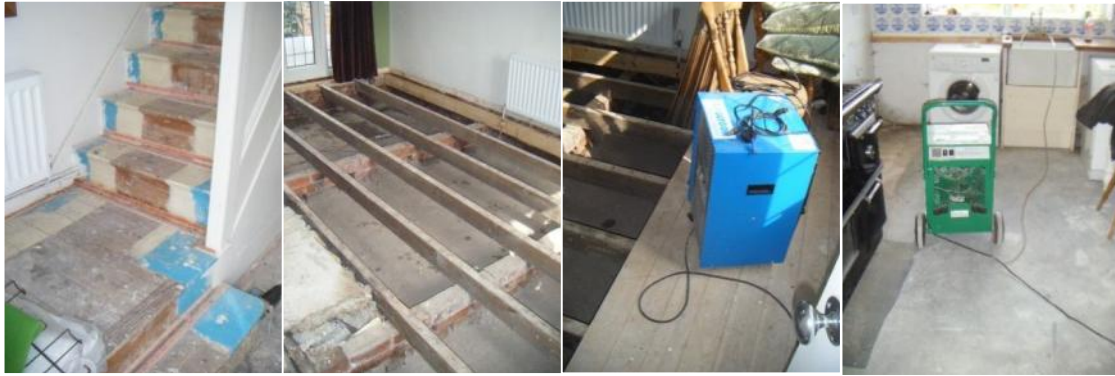
Figure 18: Flood damage to homes in West Garforth

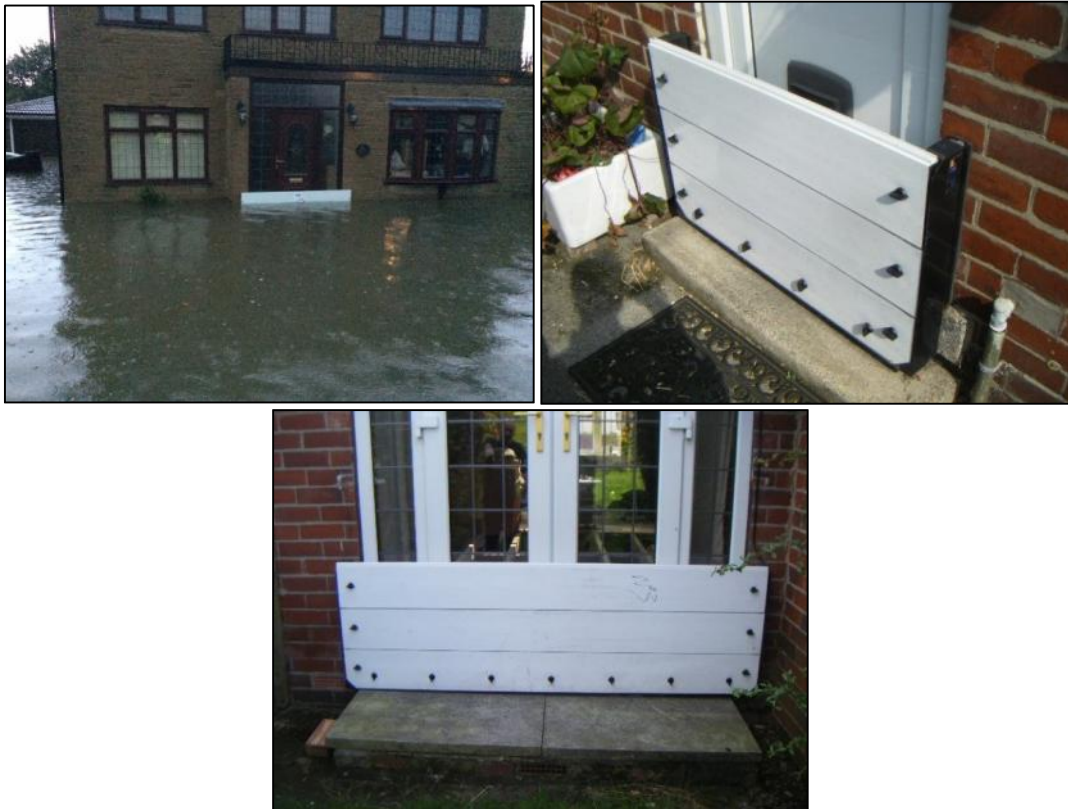
3.3.6 Property level flood resilience measures were only partially successful. Residents noted that property level protection resisted flood waters entering property through air bricks and door/patio openings, but such was the ferocity and prolonged nature of this rainfall event, flood water infiltrated into properties through walls, floors and service entry points in a manner that was virtually impossible to guard against. See figure 20 below.

Figure 20: Flood gates in position during flood event and afterwards in West Garforth  
[reproduced by kind permission of the Garforth Flood Group]

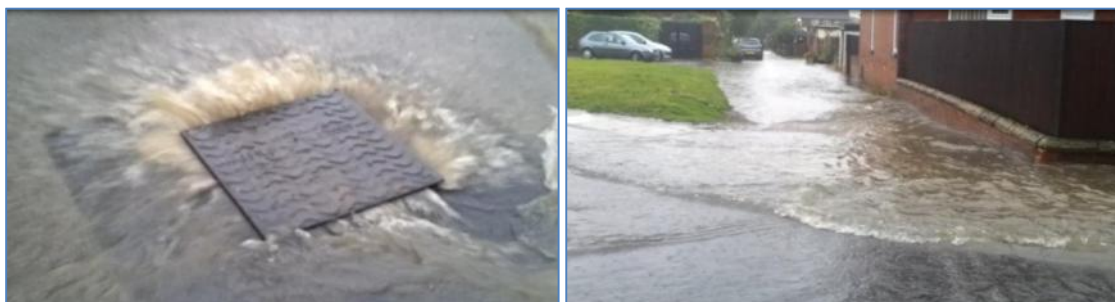
Due to overwhelming water surcharge pressure, numerous manhole covers and some frames were blown off the culverted watercourse, allowing immense volumes of floodwater to escape and gravitate to low lying areas. The resultant overland flows flooded all in their pathway and were compounded by additional flow contributions from other surcharged drainage systems paved areas, developed areas and run-off from open spaces, caused by saturated land. See figure 28 below.

Figure 28: Surcharged culvert, flood water pathway following line of the culvert overland & downhill towards Kingsway and the Alandales

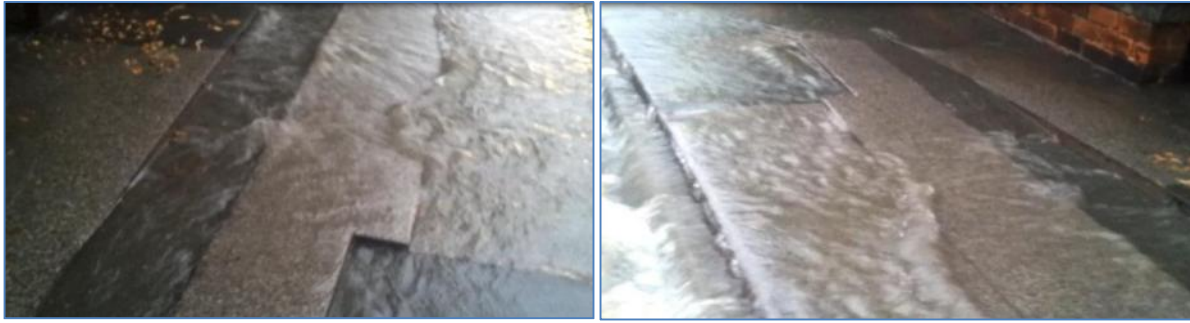
3.3.18 Most unusually, floodwater was also observed escaping under some force from beneath pavements from pressurised sections of culvert in between manhole locations, lifting whole sections of footway in the process. See figure 29 below.

Figure 29: Water escape under pressure along line of culvert

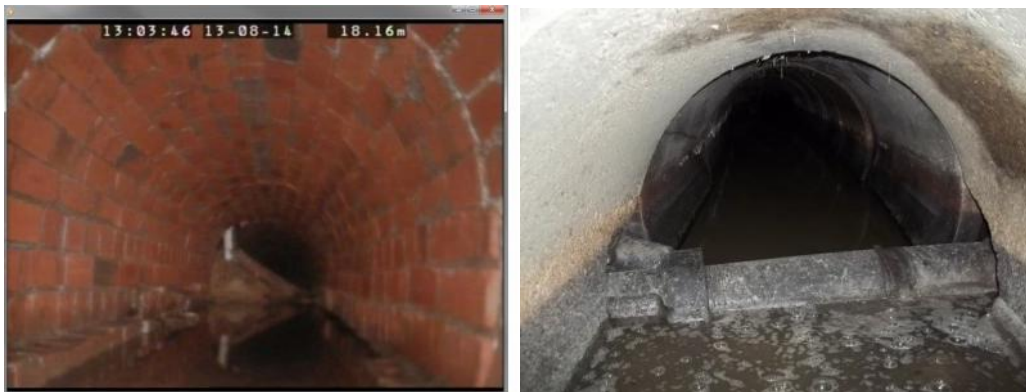
3.3.19 CCTV investigations have revealed a number of partial blockages, including a lamp column through the culvert (Lidgett Lane) and a third party service pipe through the culvert (Alandale Crescent). See figure 30 below. The lamp column was removed within 48 hours of discovery, the 150mm service pipe will take longer to divert. Other minor routine obstructions in the form of gravels and silts were also revealed by CCTV investigation – these have been removed.

Figure 30: Photograph showing new lamp column installed through the culvert main line (Lidgett Lane) and service pipe through culvert (Alandale Crescent)

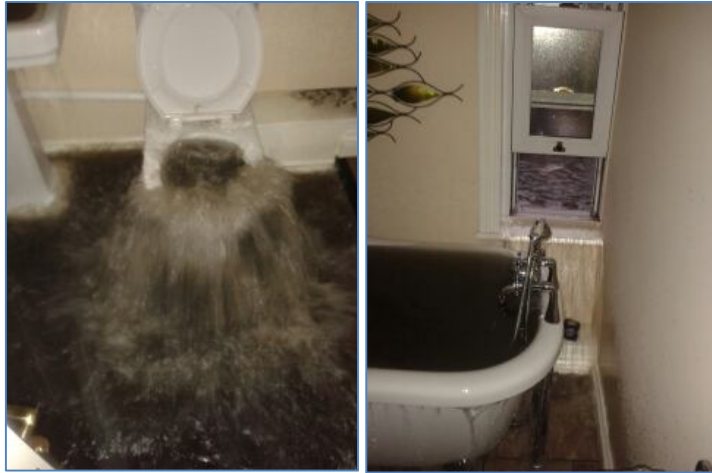
Due to overwhelming water surcharge pressure, numerous manhole covers were blown off, allowing immense volumes of floodwater to escape and gravitate to low lying areas. The resultant overland flows flooded all in their pathway and were compounded by additional flow contributions from other surcharged drainage systems, paved areas, developed areas and run-off from any open spaces caused by saturated land. Any drainage system connected to the sewer network would consequently experience similar surcharge/overload conditions as demonstrated below in figure 31.

Figure 31: Internal flooding caused by sewer surcharge and overload  
[reproduced by kind permission of the Garforth Flood Group]

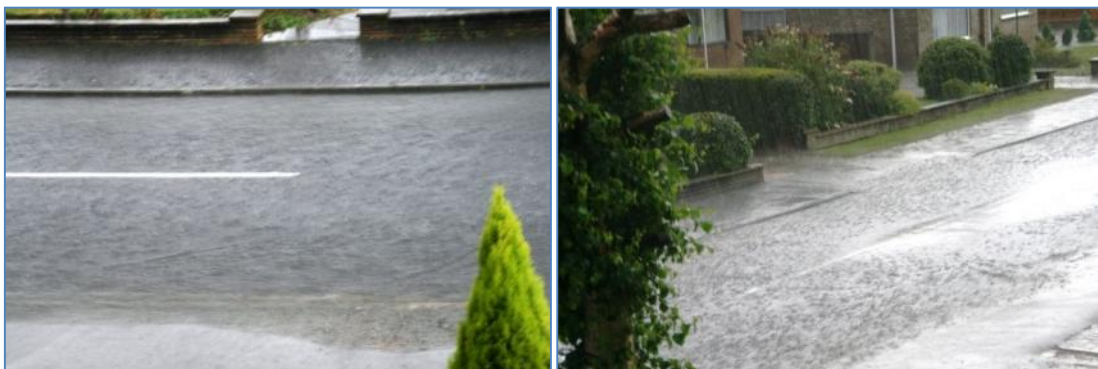
Road gullies in general were not functional regardless of their service condition, due to the surcharge conditions of receiving drainage systems, but the extreme nature of this rainfall event would have far exceeded the design criteria for the highway drainage. The resultant overland flows flooded all in their pathway and were compounded by additional flow contributions from other surcharged drainage systems, paved areas, developed areas and run-off from any open spaces caused by saturated land. See figure 32 below.

Figure 32: Grange Avenue, road gullies totally overwhelmed  
[reproduced by kind permission of the Garforth Flood Group]

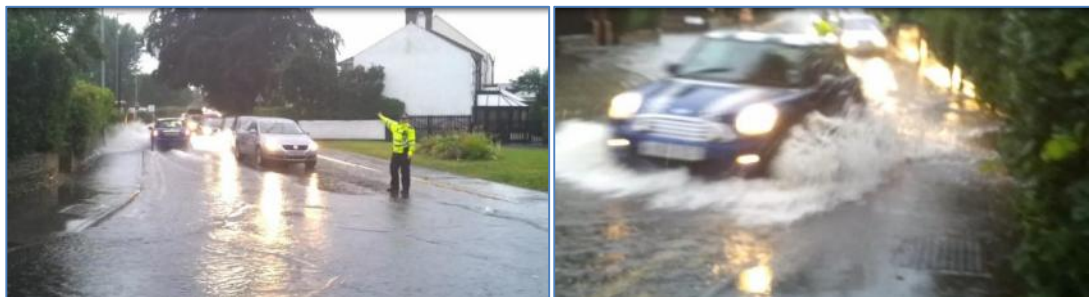
- 3.3.26 The cause of the flooding was the extreme volume of water leading to surface water (pluvial flooding) flooding. Which appears to have been exacerbated by: (i) surcharged manholes, and road gullies and (ii) supplemented by extreme surface water runoff from the developed areas of Garforth occupying higher ground. There is insufficient information to determine the proportionate share of these sources.
- 3.3.27 The performance of some culverted watercourses was compromised by partial blockages.
- 3.3.28 The performance of Yorkshire Water assets has yet to be verified / assessed.
- 3.3.29 An uncharted and dysfunctional drain along Lidgett Lane, south of Lowther Avenue, contributed to the formation of a lake at the junction of Lowther Avenue and Lidgett Lane, which had to be controlled by WY Police on the night of 8 August. See figure 34 below.

Figure 34: photographs of dangerous lake at the junction of Lowther Avenue and Lidgett Lane

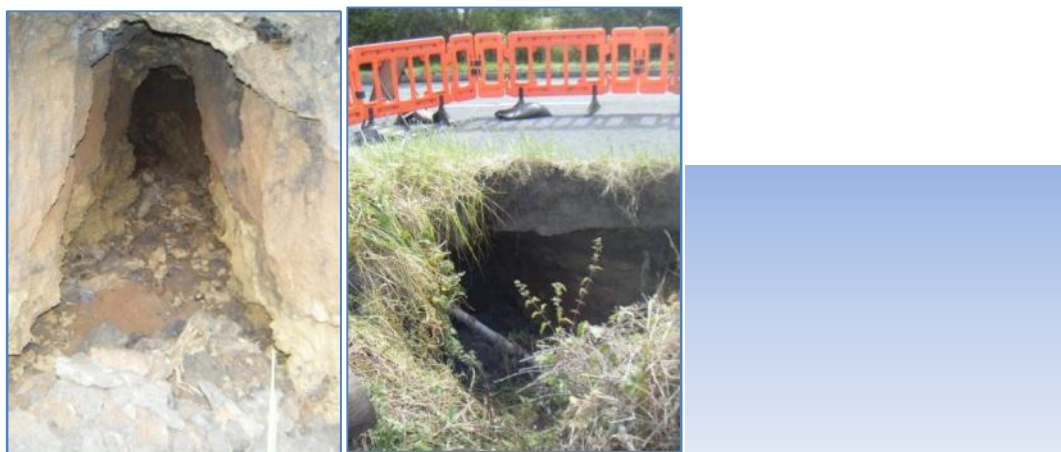
Figure 36: sink hole below B6137, Kippax

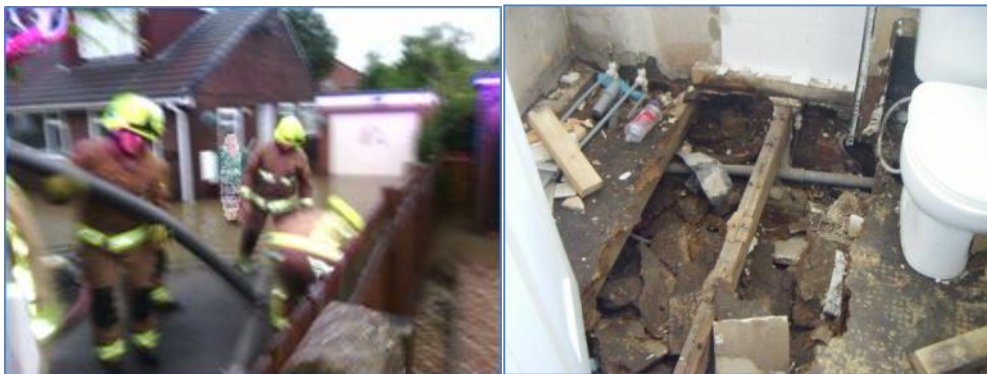
Figure 38: photographs of Fire Service attending flood victims, and devastation caused by internal flooding in Kippax

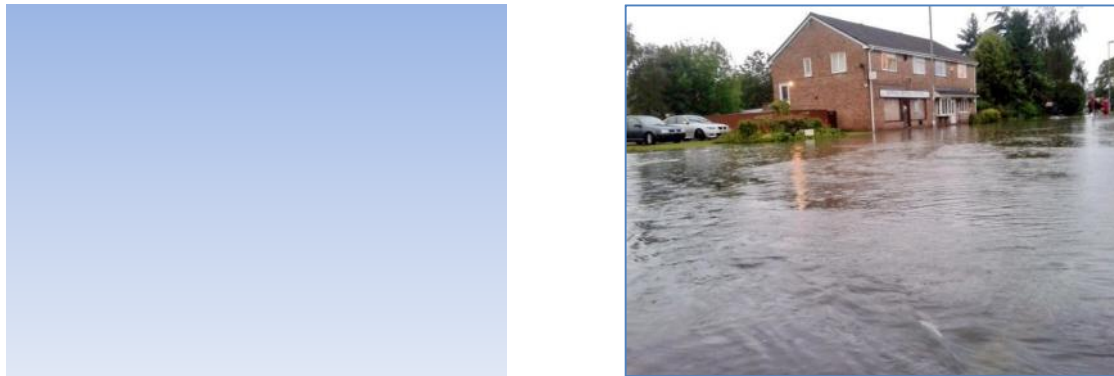
3.4.5 The floodwater was caused by the extreme volume of water from overland run-off, which appears to have been exacerbated by surcharged combined sewers, surface water sewers, private drains, highway gullies, , culverted watercourses and open watercourses. Several sizeable lakes developed to depths up to 1000mm, notably Gibson Lane, Brigshaw Lane, Leeds Road and Valley Road. See figure 40 below.

Figure 40: Brigshaw Lane and Gibson Lane, Kippax

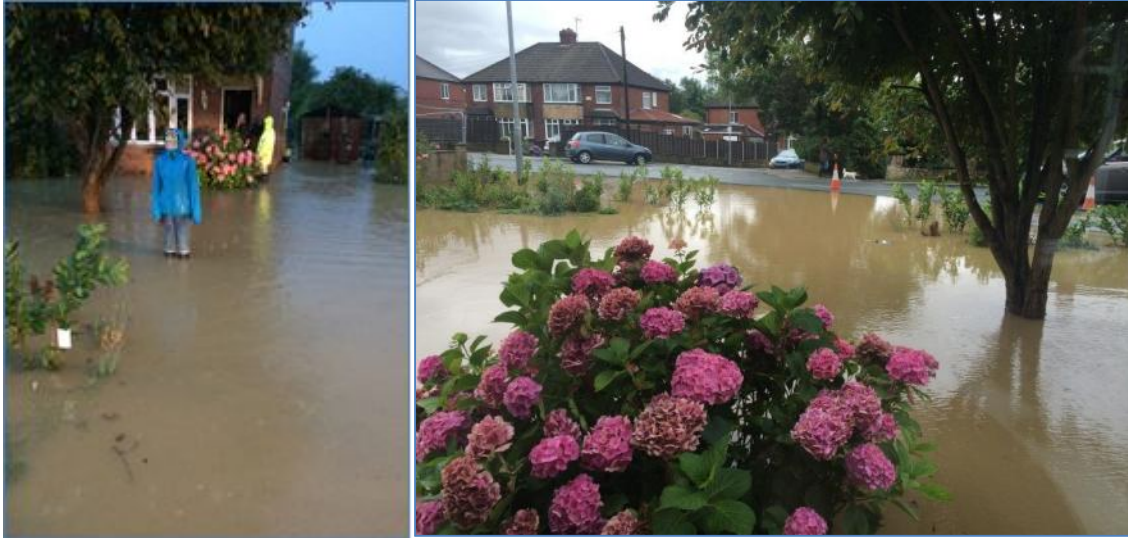
Figure 42: Leeds Road B6137, internally-flooded property and carriageway

3.4.10 Due to overwhelming water surcharge pressure of the culverted watercourse caused by agricultural surface water runoff, immense volumes of floodwater escaped and gravitated overland to lower lying residential properties. The resultant overland flows also flooded the B6137, Leeds Road as shown above in figure 42.

3.4.11 Internal CCTV inspection of the surcharged riparian owned culverted section by Leeds City Council surveyors has revealed no blockages or defects.

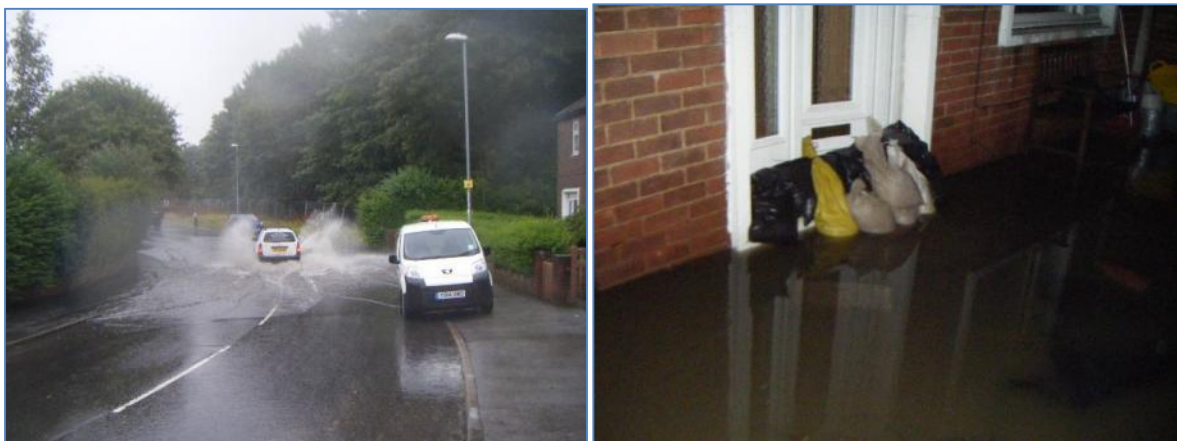
Figure 43: Valley Road and adjacent property internally flooded

3.4.13 Internal CCTV inspection of the nearby riparian culverted section by Leeds City Council surveyors has revealed no blockages or defects and it is, therefore, assumed that the culverted watercourse played no part in flooding at this location.

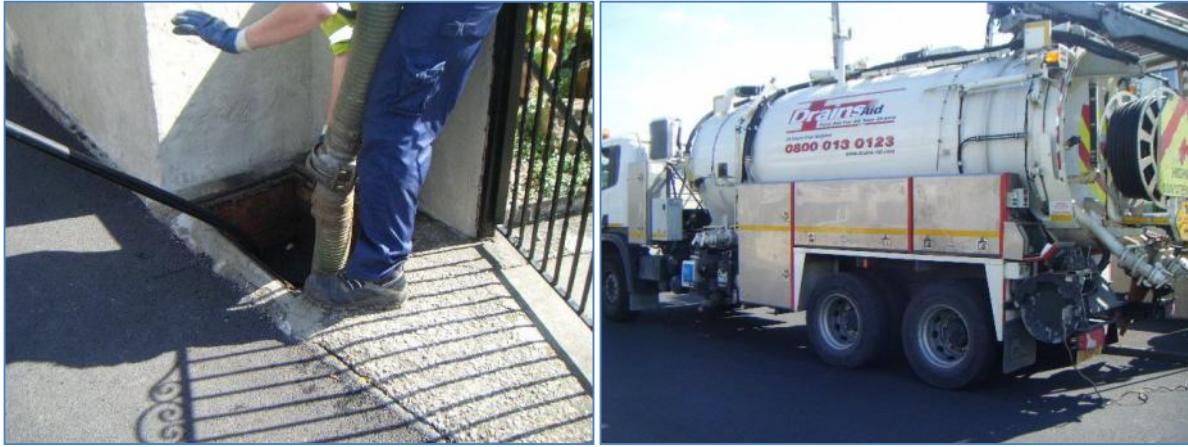
- 3.4.20 Due to overwhelming water surcharge pressure caused by a blockage within the private sewer network, even greater volumes of flood water escaped upstream of this area and gravitated overland to flood lower lying residential properties. See figure 46 below.

Figure 46: FRM clearing blocked private sewers in The Drive, Saturday 9<sup>th</sup> August
