**FLOOD INVESTIGATION REPORT**  
Under Section 19 of the Flood and Water Management Act 2010

**South East Leeds**  
8<sup>th</sup> & 10<sup>th</sup> August 2014

**Prepared by**  
**Flood Risk Management Team**  
**City Development Directorate**  
**Leeds City Council**  
**July 2015**

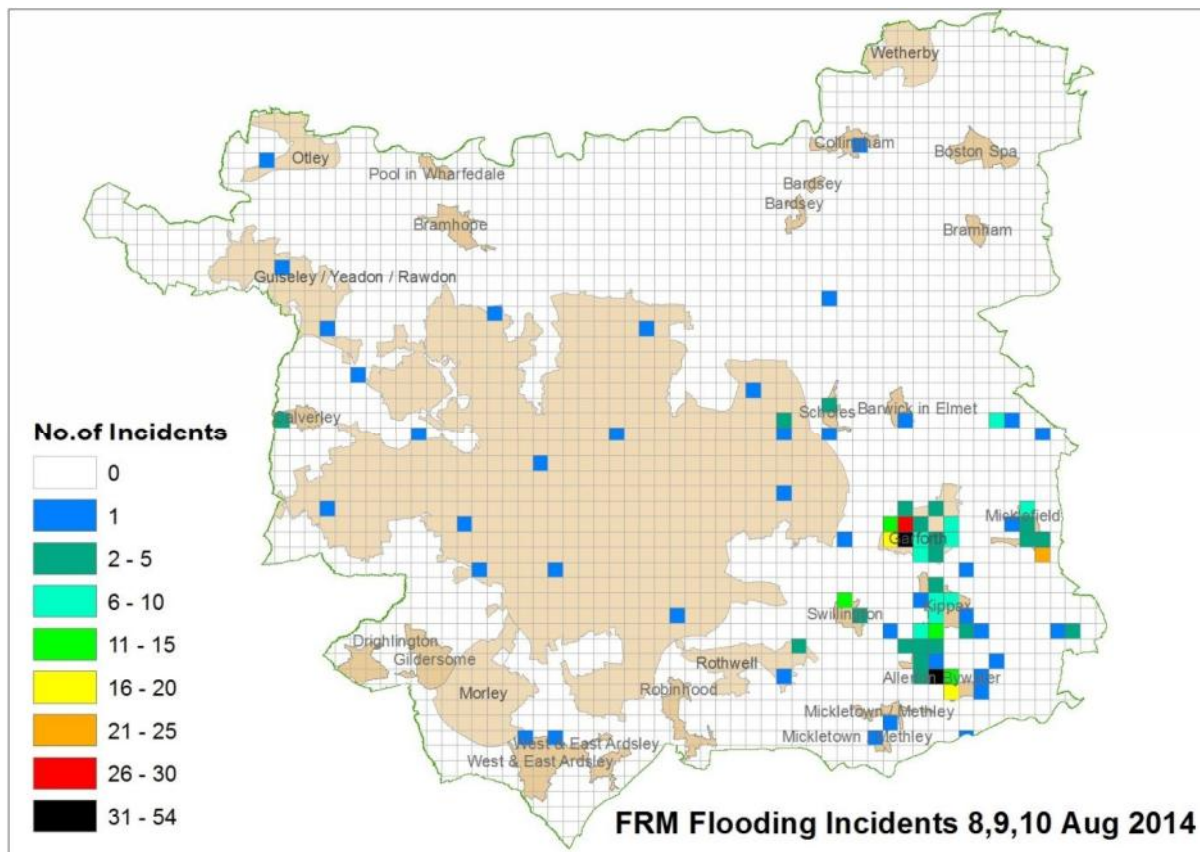
Figure 1, flooding incidents by frequency and location (per 500x500m square)  
 Note highest frequency in Allerton Bywater & Garforth

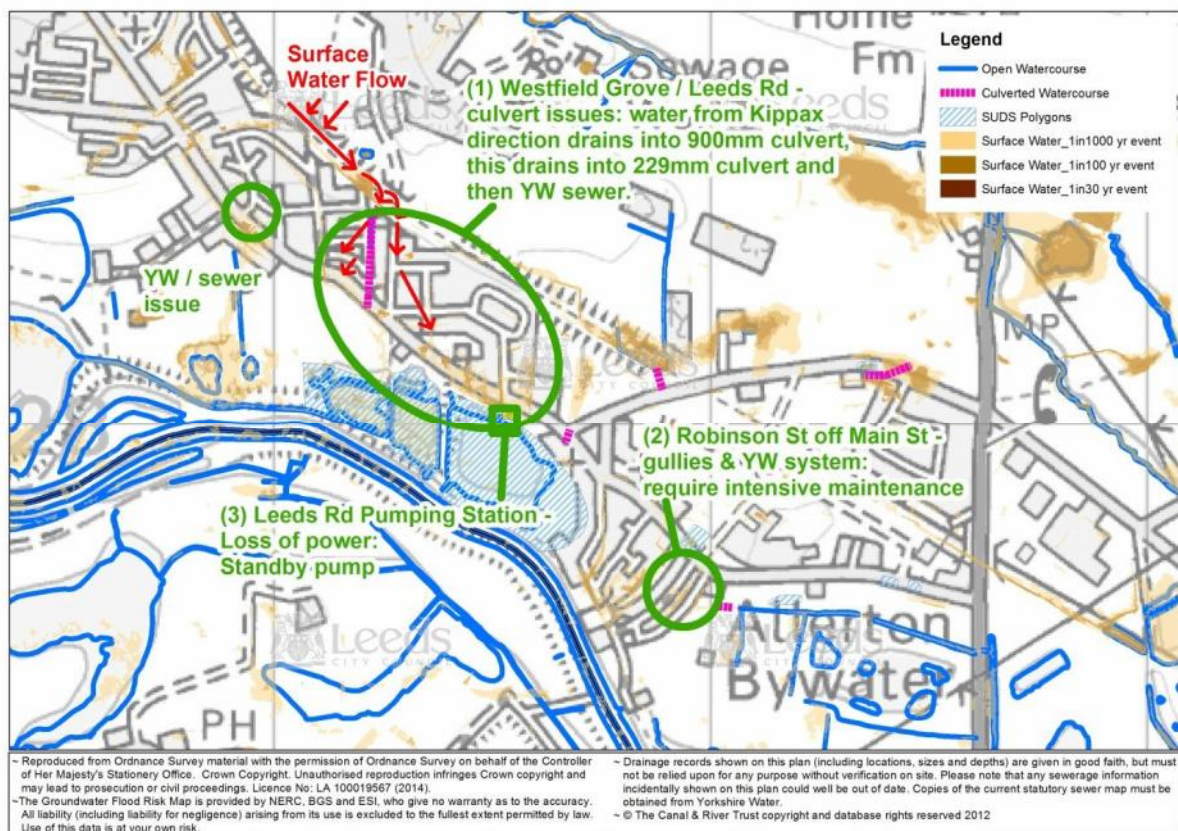
3.2.3 It is reported that at least 22 properties in Allerton Bywater were flooded internally during the rainfall event of the August 8<sup>th</sup> and 10<sup>th</sup> 2014. Flood depths internally were in the order of up to 300 mm. See figure 4 below for plan of Allerton Bywater showing incidents relating to culvert position and low lying ground and figure 5 showing flood damage to homes.

Figure 4: Plan of Allerton Bywater showing incidents relative to culvert position (shown pink) and low lying ground (shown in browns).

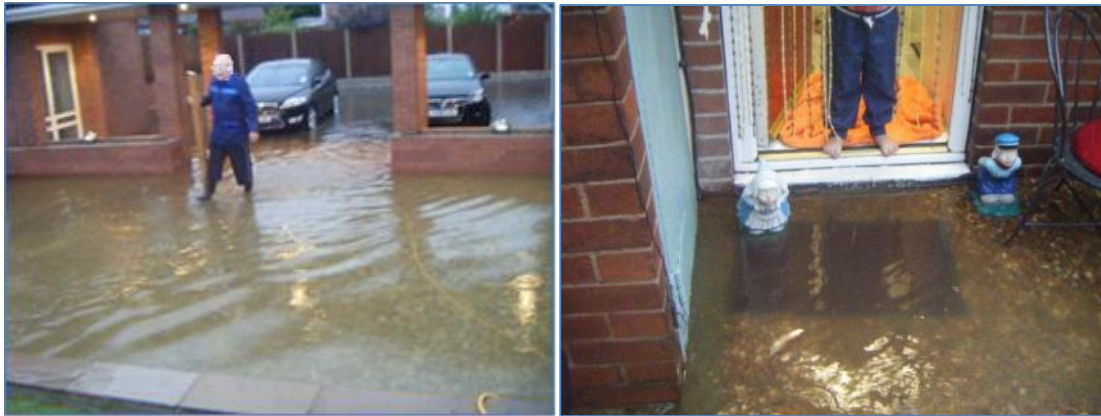
3.2.4 Countless properties suffered flooding to gardens as shown in figure 6 below.

Figure 6: Flooded gardens in Allerton Bywater

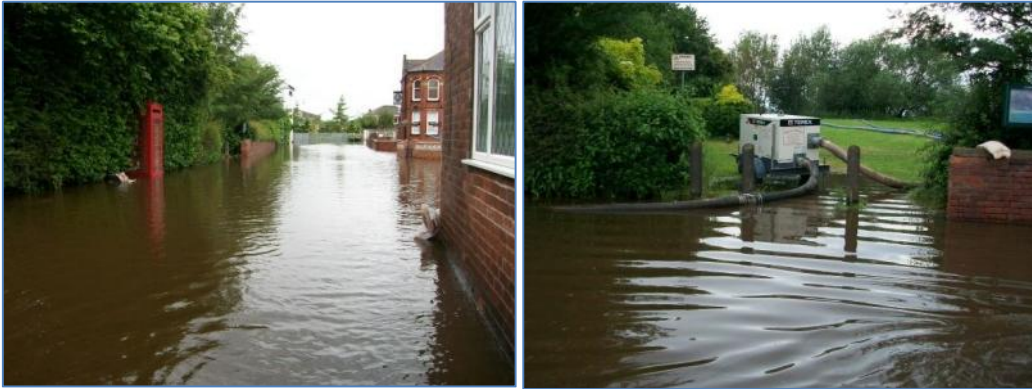
3.2.6 The Allerton Bywater area has a long history of flooding problems stretching back many years, and some residents are severely impacted because their homes, gardens or streets are subject to frequent inundation. Most recently, many properties were flooded internally in the summer of 2012 requiring a major pumping exercise to afford some relief as shown in figure 7 below.

Figure 7: historic flooding in 2012 off Main Street, Allerton Bywater. Several pumps were required to reduce water levels.

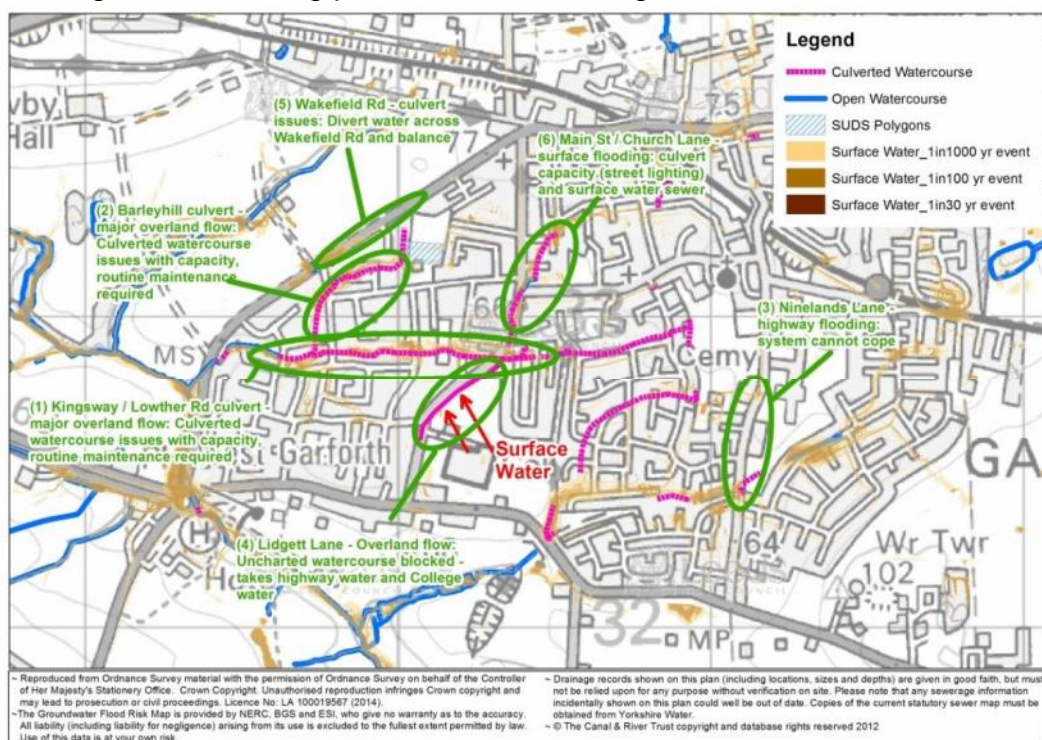
3.3.3 It is reported that at least 34 properties in Garforth as a whole were flooded internally during the rainfall event of the 8<sup>th</sup> and 10<sup>th</sup> August 2014. Flood depths internally were in the order of 200 mm. Some ground/basement floors are believed to have been rendered uninhabitable and substantial remedial works were necessitated, including the total removal of floorboards, joists, plasterwork, etc., with some residents having sought temporary accommodation until their houses have been dried out and repaired. See figure 17 showing incidents relative to culvert position and low lying ground and figure 18 showing photos of flood damage in West Garforth.

Figure 17: Plan of West Garforth showing incidents relative to culvert position (shown pink) and low lying ground (shown in browns)

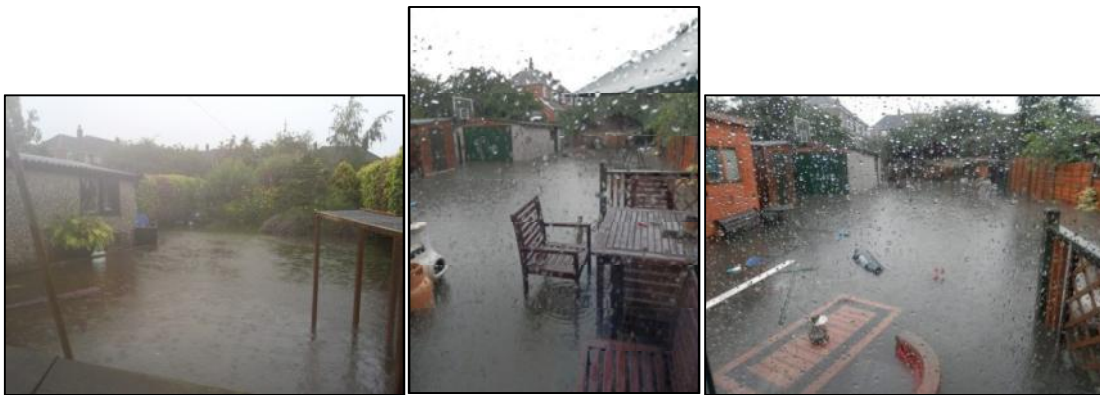
3.3.4 Countless properties suffered flooding to gardens. See figure 19 below.

Figure 19: Flooded gardens in West Garforth  
[reproduced by kind permission of the Garforth Flood Group]

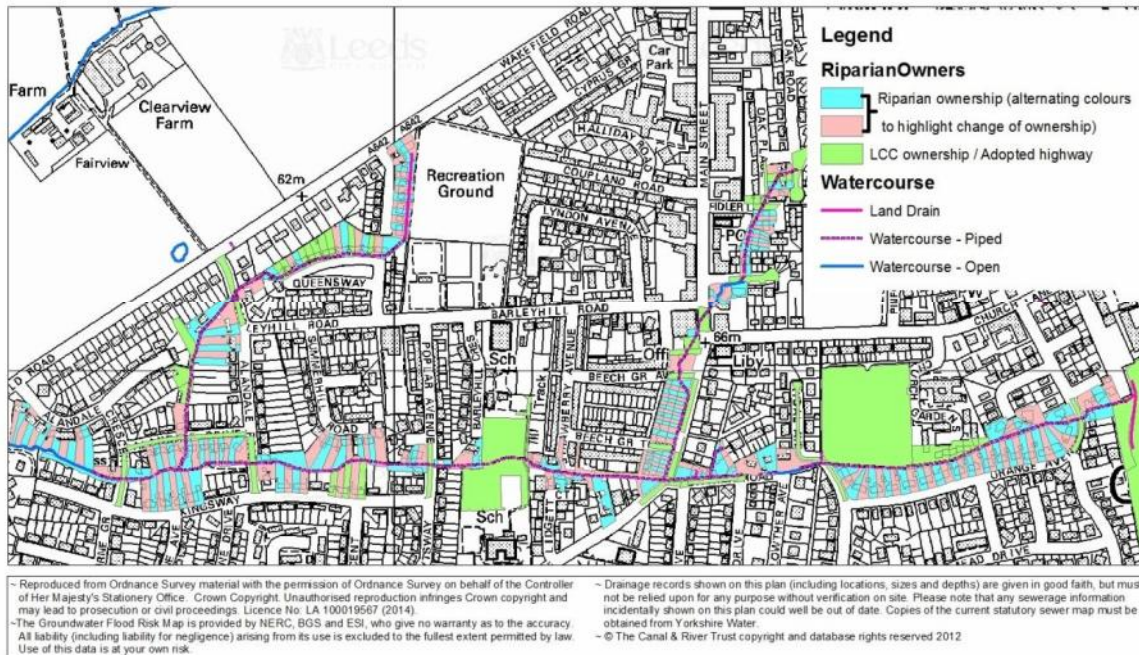
- 3.3.9 The backbone of the drainage infrastructure is a system of inadequate, riparian-owned, culverted watercourses, principally passing through hundreds of private properties (see figure 26 below).

Figure 26: Riparian ownership along watercourse route in West Garforth

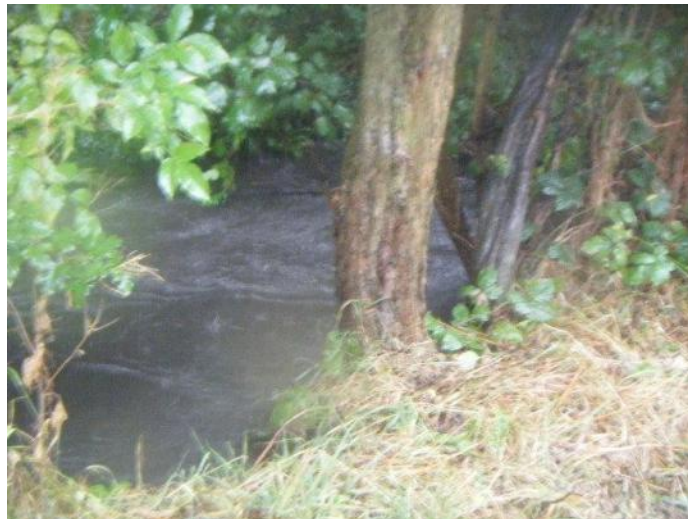
From resident eye witness accounts and observations on the night, by FRM staff, the watercourse did not overtop its banks and remained in channel. See figure 27 below.

Figure 27: photograph taken on the evening of August 8th 2014 showing watercourse in channel

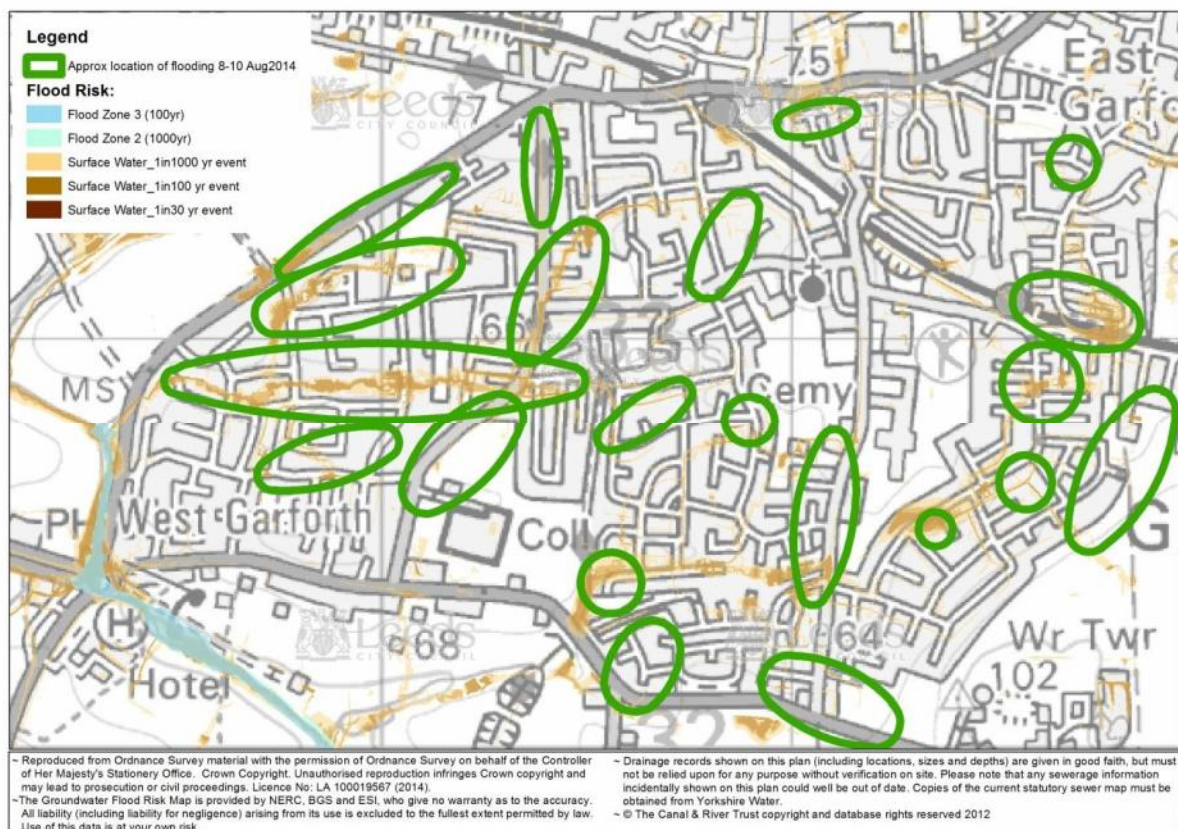
Although many long-term residents do not recall previous flooding of this magnitude (many say it even surpassed 2007), it should be noted that most of the affected flood area falls within low lying areas. In most cases it has been shown (see 3.3.12) that these areas predominately coincide with previous open channel natural valleys, watercourses and later culverts.

These areas are identified as susceptible to surface water flooding as indicated by the Environment Agency's flood risk model (see figure 33 below).

Figure 33: incidents related to topography and flood risk zones

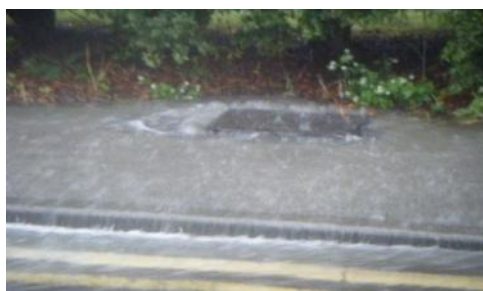
- 3.3.30 The lake above, was compounded by a connection from adjacent playing fields and this is the subject of further investigation. See figure 35 below.

Figure 35: photograph of connection from Garforth Community College playing fields, Lidgett Lane

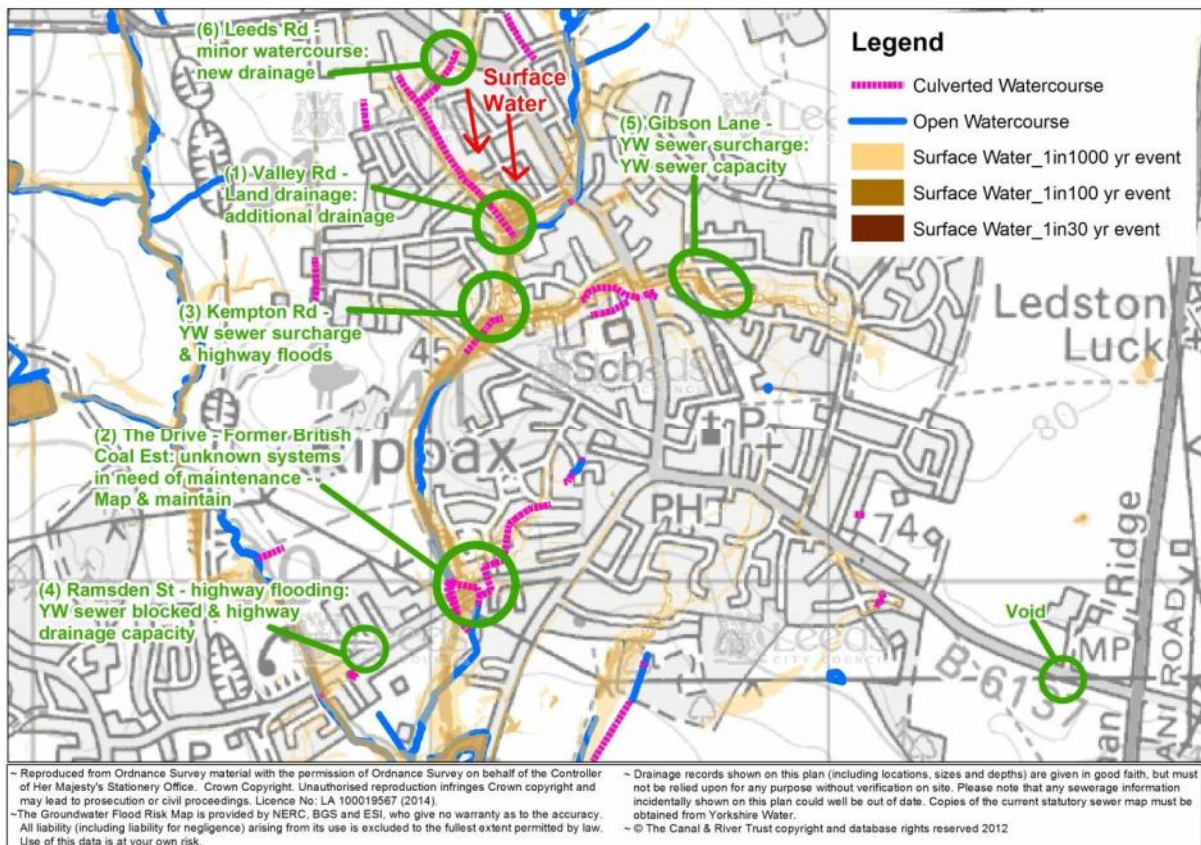
- 3.4.3 It is reported that at least 28 properties in Kippax as a whole were flooded internally during the rainfall event of the 8th and 10th August 2014. Flood depths internally were in the order of up to 300 mm. See below figure 37 for a plan of Kippax showing incidents relative to culvert position and low lying ground and figure 38 showing the damage caused by the floodwater.

Figure 37: plan of Kippax showing incidents relative to culvert position (shown pink) and low lying ground (shown in browns)

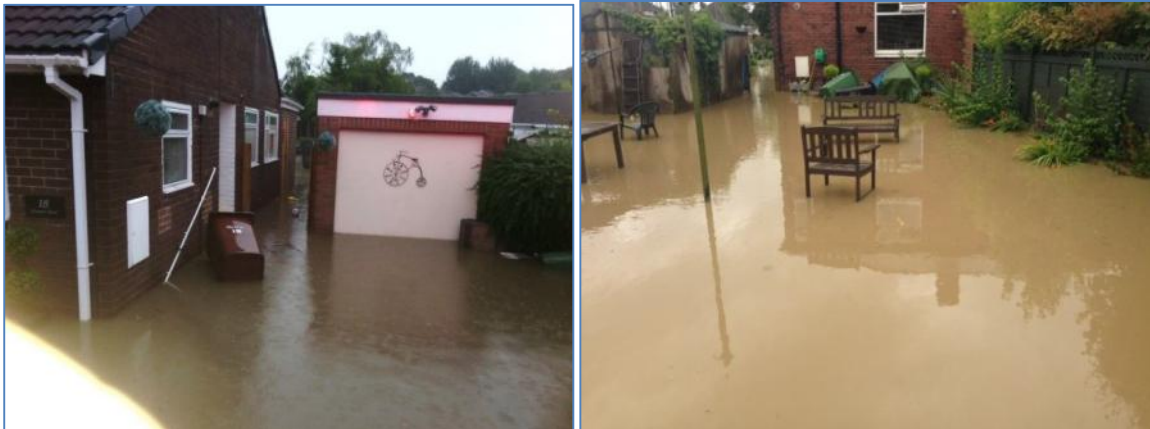
3.4.4 Countless properties suffered flooding to gardens. See figure 39 below.

Figure 39: flooded gardens in Kippax

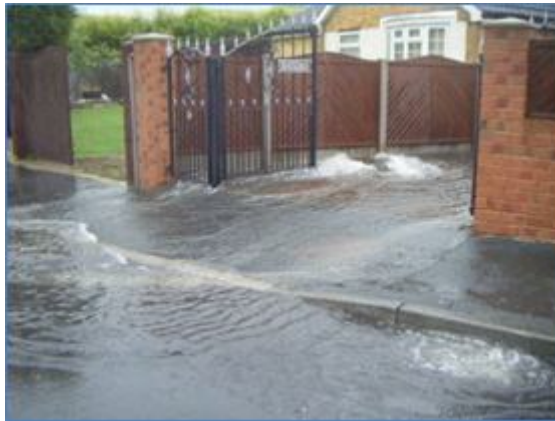
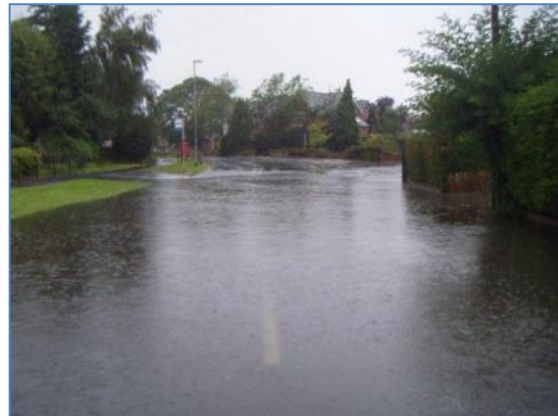
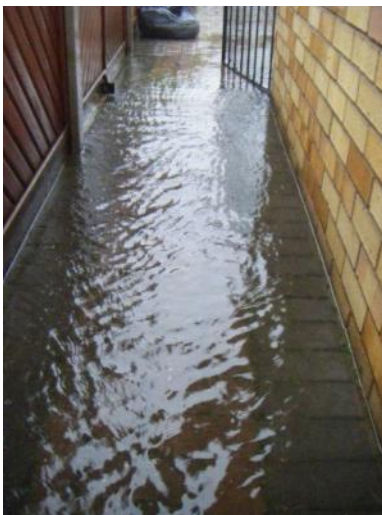
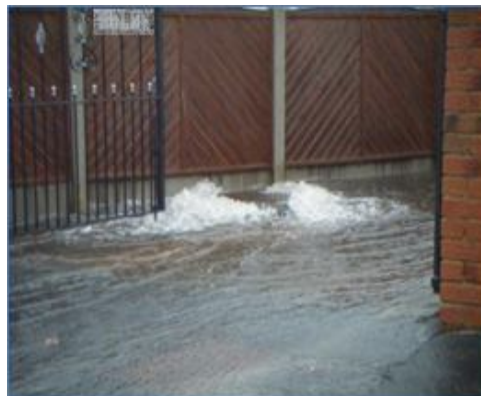
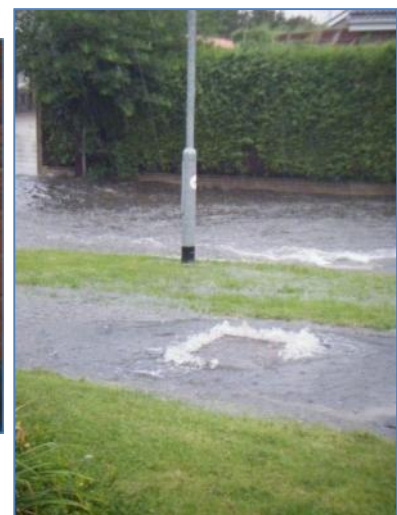
3.4.14 Due to overwhelming water surcharge pressure on the public sewer network, immense volumes of flood water escaped and gravitated overland to flood lower lying residential properties. The resultant overland flows also flooded Gibson Lane and Leeds Road as can be seen below in figure 44.

Figure 44: photographs of flooding at Gibson Lane, Pondfields Drive & Moorleigh Close

3.4.15 The highway gullies drain into the public surface water sewer system, and the inability of the highway drainage system to discharge to these surcharged systems will have contributed to the flooding.

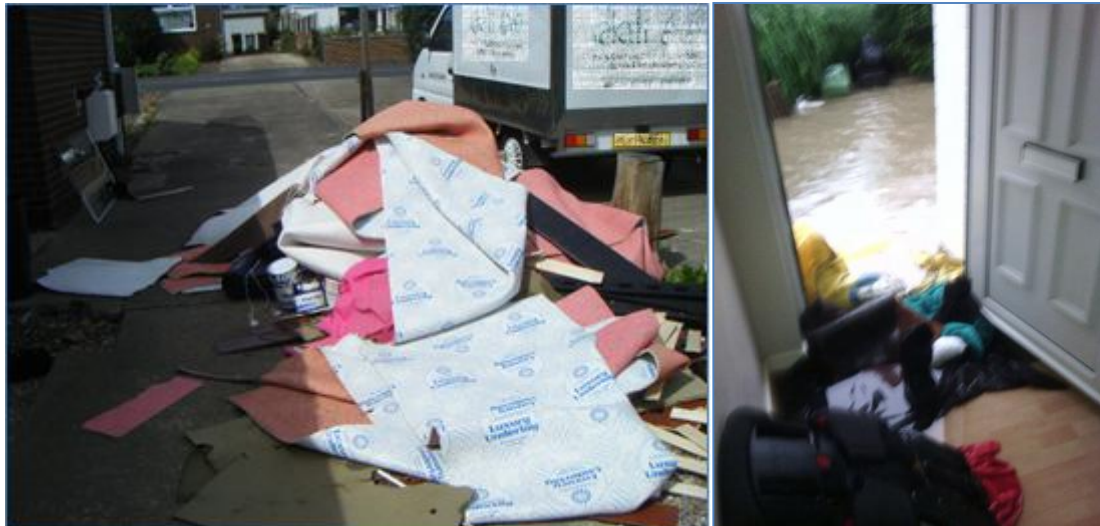
Figure 45: flood damage and residents desperately attempting to defend their homes with sandbags

- 3.4.16 Due to overwhelming water surcharge pressure on the public sewer network, immense volumes of flood water escaped and gravitated overland to flood lower lying residential properties. Eye witness reports state that manhole covers were blown off and discarded several metres away from the manhole shaft. See figure 45 above.

- 3.4.17 Public sewer surcharge on Ebor Mount resulted in extensive collateral damage to the carriageway. The resultant overland flows contributed to flooding property on nearby Westfield Lane.

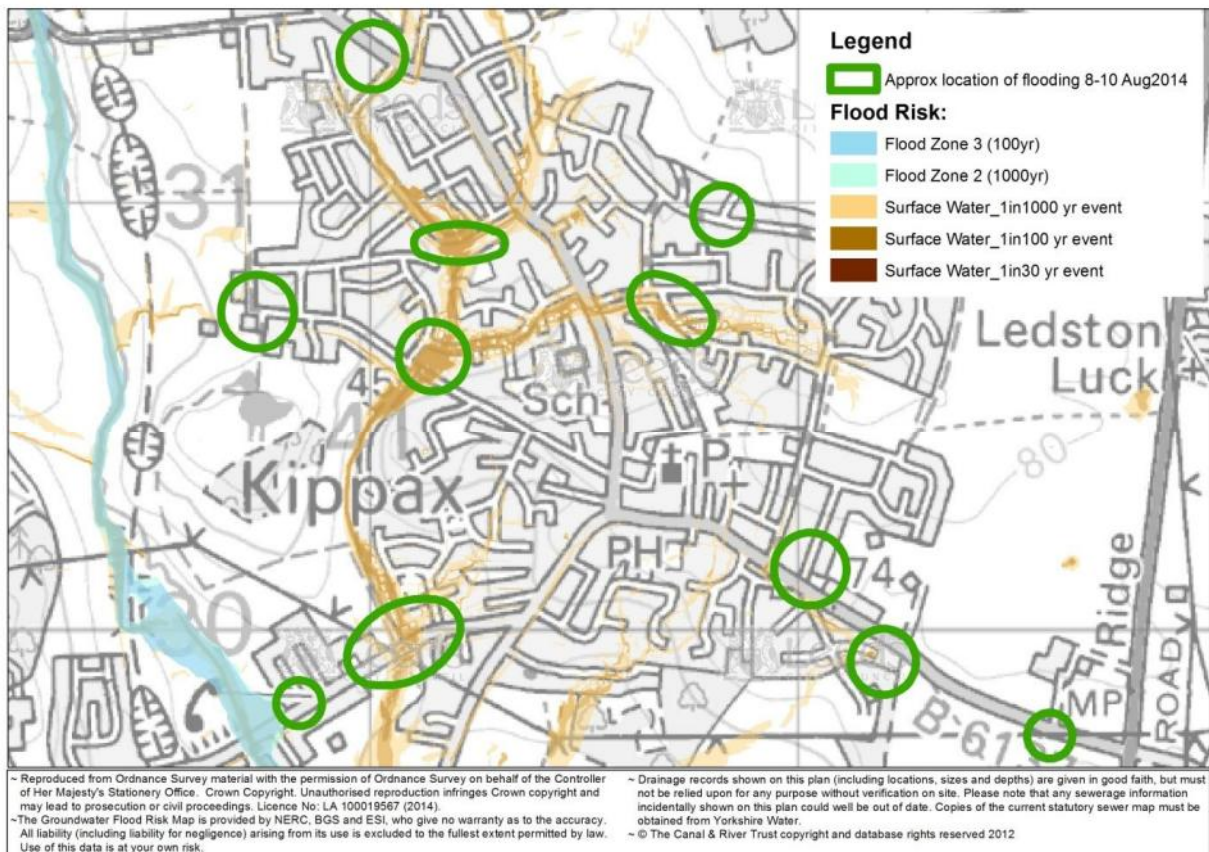
3.4.26 It should be noted that most of the affected flood areas fall within valleys, low lying areas and the overland flows track towards natural watercourses/becks. These areas are identified as susceptible to surface water flooding as indicated by the Environment Agency's flood risk model (see figure 47 below).

Figure 47: incidents related to topography and flood risk zones

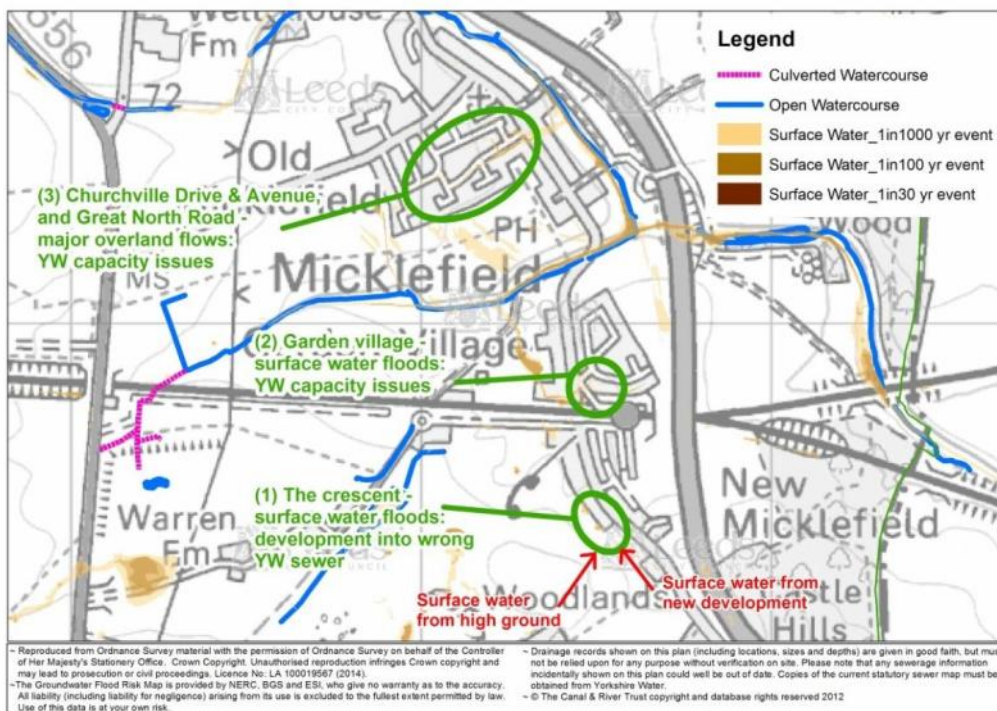
3.5.3 It is reported that at least 18 properties in Micklefield as a whole were flooded internally during the rainfall event of the August 8<sup>th</sup> and 10<sup>th</sup> 2014. Flood depths internally were in the order of up to 300 mm. See figure 48 for plan of Micklefield showing incidents and low lying ground and figure 49 showing photos of damage caused by floodwater.

Figure 48: plan of Micklefield showing incidents and low lying ground (shown in browns). [Whilst detailed information has been recorded, due to the restrictions imposed by the Data Protection Act flooding locations have been aggregated so as not to identify individual properties]

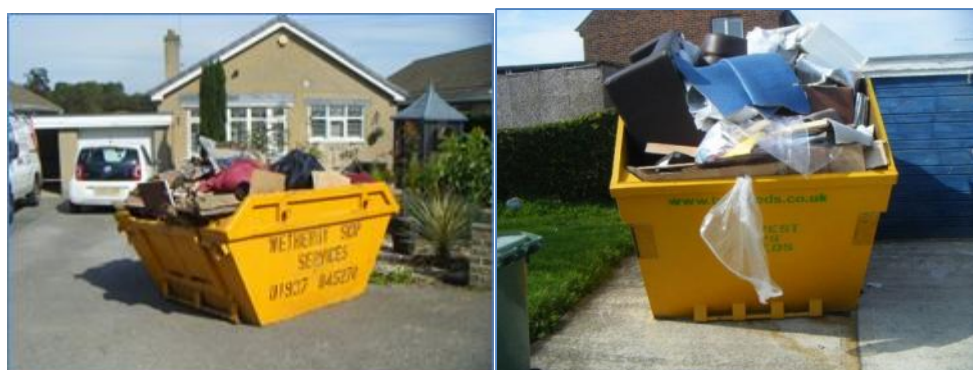
Figure 49: clearing flood damaged properties in the aftermath flooding, Micklefield

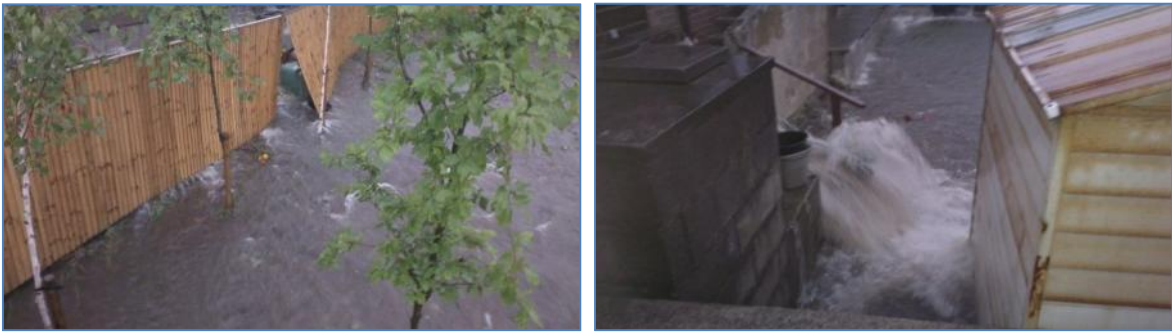
3.5.4 Countless properties suffered flooding to gardens, as shown in figure 50.

Figure 50: gardens in flood, Micklefield

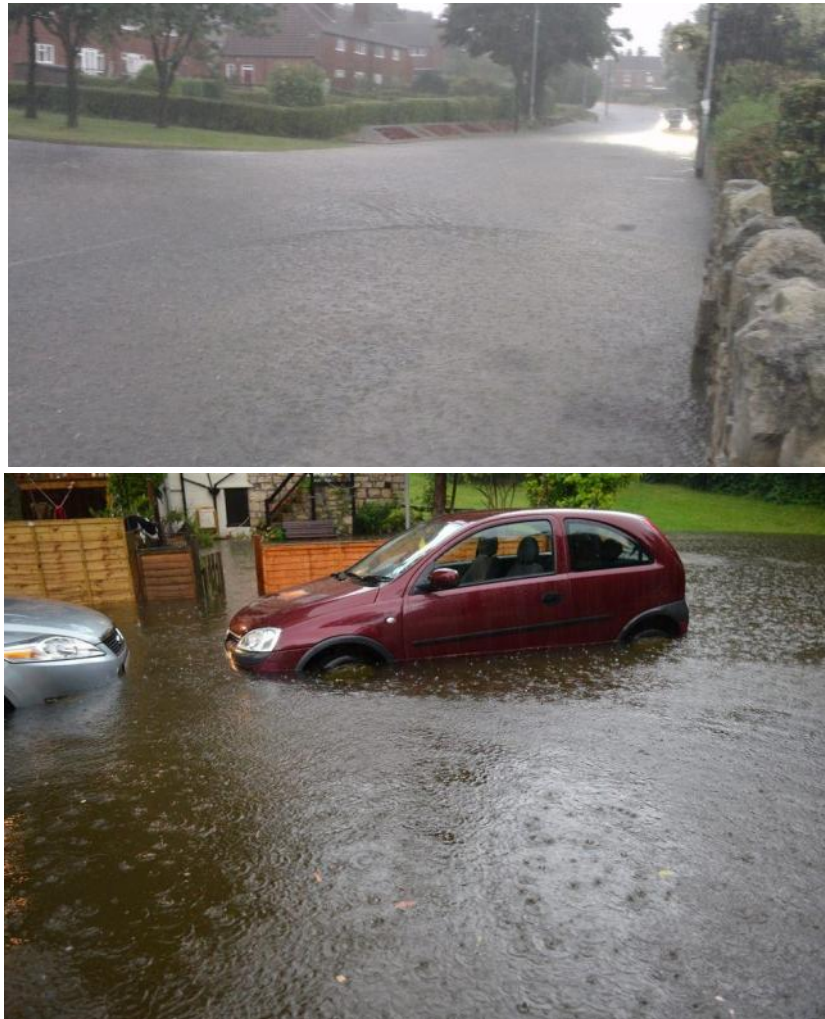
3.5.5 The floodwater came from the extreme volume of water of overland run-off, with surcharged combined sewers, surface water sewers, private drains and highway gullies. Several sizeable lakes developed to depths up to 1000mm, notably The Crescent and Great North Road. See figure 51 below.

Figure 51: photographs of deep water, Great North Road & The Crescent, Micklefield

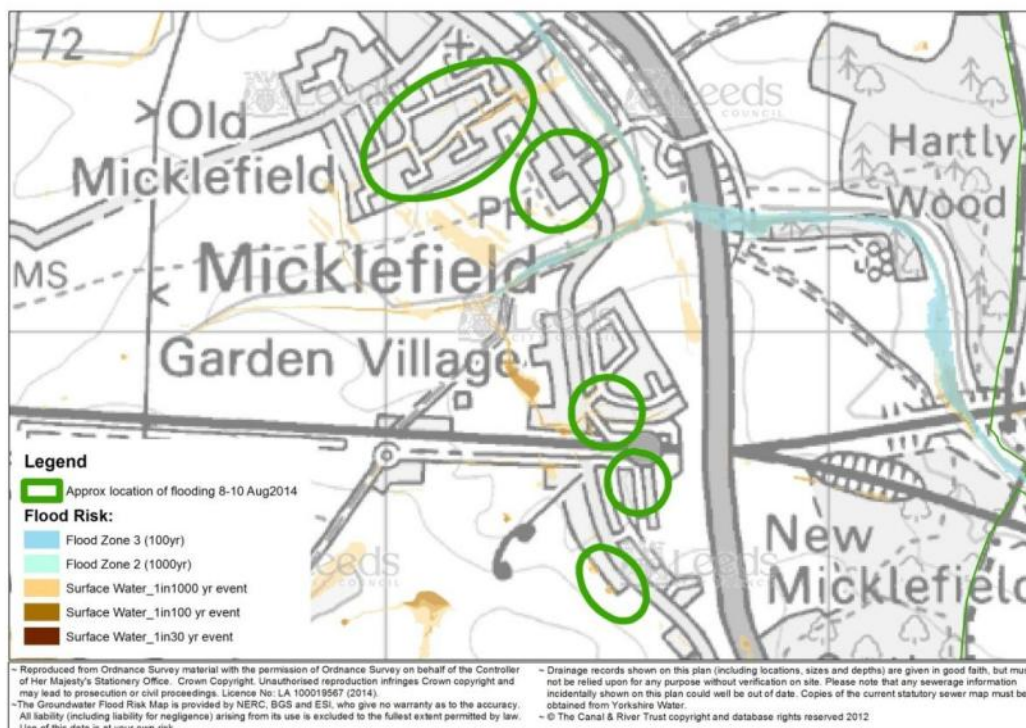
Figure 53: incidents related to topography and flood risk zones

- 3.5.15 It should be noted that most of the affected flood areas fall within natural, low lying areas as the overland flows track towards distant natural watercourses/becks. These areas are identified as susceptible to surface water flooding as indicated by the Environment Agency's flood risk model (see figure 53 above).
- 3.5.16 In summary, the storm that occurred in Micklefield on August 8<sup>th</sup> and 10<sup>th</sup> was of exceptional intensity and exceeded current or historic design standards for all sections of drainage infrastructure and it is certain that substantial and localised flooding would have occurred irrespective of the condition or state of operation of the existing drainage network.
